JEEP HOSPITAL

Each month Dr Jeep (Tony Whitehead) takes us through the trials and tribulations at his “Jeep Hospital”, USA 4X4 Jeep Specialist in Melbourne, Victoria. Over 20 Jeeps are admitted weekly for servicing and suspension work through to differential, transmission and engine rebuilds. Dr Jeep explains the diagnosis, the corrective surgery and future care of these vehicles.

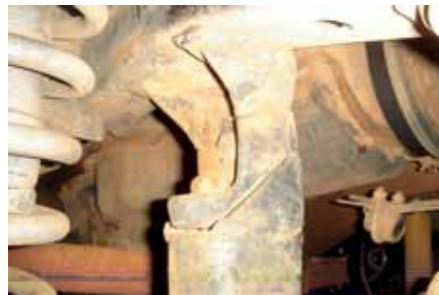
BIG TJ TROUBLE

A very tall TJ came in for a once over recently. It was built in NSW and had an engineer’s certificate BUT that wasn’t going to help here in Victoria. The dropped front panhard rod bracket was literally tearing off the chassis. It was the sort of repair that required a complete bracket swap, re-welding on and beefed up from the opposite side as well. The Jeep had a lot of other issues too and is currently on hold for repairs or may actually be simply parted out. Jobs like this are liability nightmares for mechanical workshops and something we’d farm out to a chassis repair shop. If the lift wasn’t so massive and the mods so sketchy, this Jeep would still be drivable but this problem is as serious as it could get. Imagine that snapping at 110kph with your five inch lifted TJ on 35 inch tyres. I’d rather not.

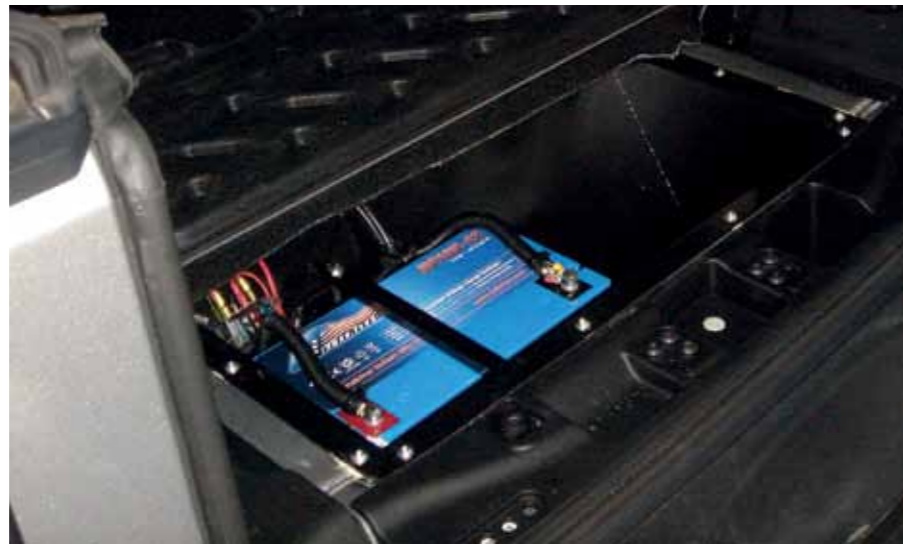
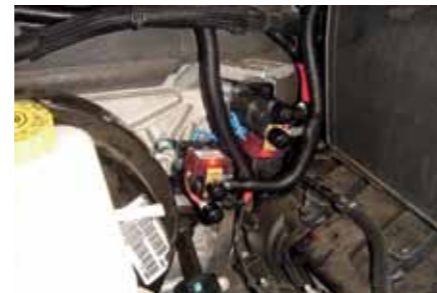
DUAL BATTERIES

This MY13 JK V6 was fitted with a bigger main battery and a second battery in the rear of the Jeep. After removing the stock exhaust and rear muffler there was room to fit a Uneck rear battery compartment box. We had to cut the original box out and make the after market box fit in. We ran a couple of Anderson plugs and a 12V/USB through its own fuse panel to supply power from the 105Ah Full River fully sealed deep cycle battery. This battery is monitored through the Red Arc regulator and circuit breaker mounted in the engine bay. They are fully waterproof and can be

mounted in the engine bay. There isn’t much room to play with in the JK engine bay so you need to get creative. A Rancho exhaust system was fitted to finish the job off.

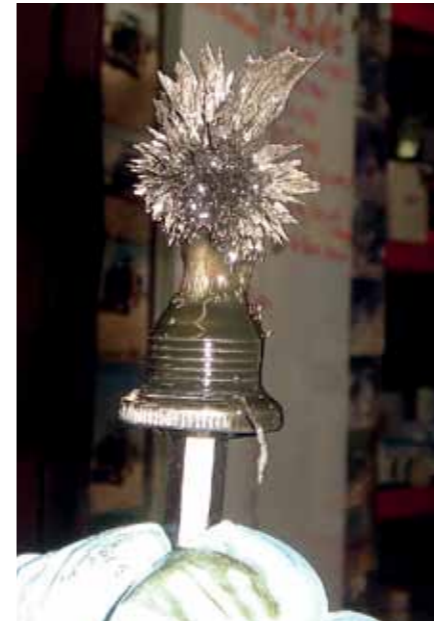
DANA 35C PROBLEMS

Another XJ came in recently for a check-up. It had a rumble, or three. It was running an ARB diff cover with a magnetic drain plug and after a quick inspection we found this little beauty, metal filings, LOTS of metal filings. So off with the cover and rear drive shaft to feel the grumble by hand, the 35C has a C-clip arrangement so we popped the C-clips out then the axles, to find one of the axle bearings had failed. The other side was ok, we also found twisted splines on the axle, odd as the other side was ok. Maybe that “brand X” HD axle never got the induction hardening it should have got. The carrier bearings had also suffered a small amount of damage and will be replaced. The pinion seemed smooth and will be left this time. Ideally the pinion and carrier bearings are replaced together. But that is another job again – resetting the pinion depth, so to be cost effective on an older Jeep we won’t do that this time.

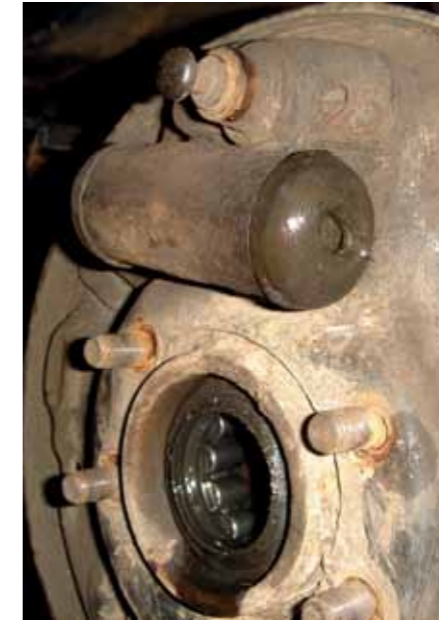
It never ends, that drum rear end on the XJ also needed wheel cylinders, they had been leaking for a long time and the rear shoes were all glazed over. Pull your drums off now and then and feel the rubber cap back. If you see fluid they’re shot.

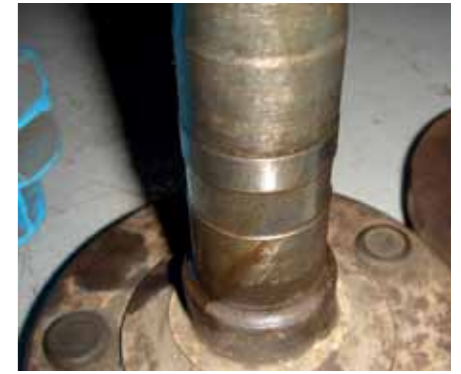
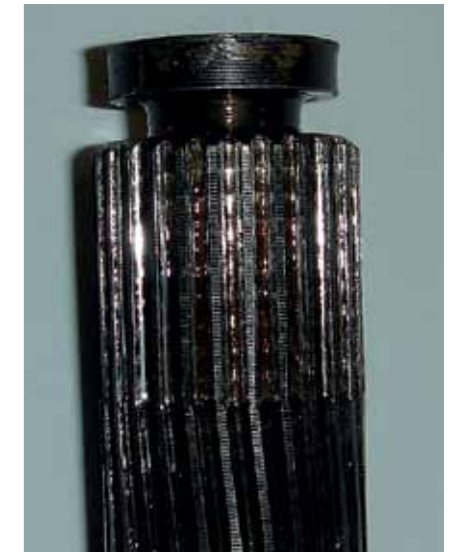
The XJ D35C rear end runs the bearing on the inner part of the axle. This axle has been chewing itself to bits for a while and you can see where the roller bearing has been chowing the face. All it’s good for now is a tent peg. Twisted spline shown below.

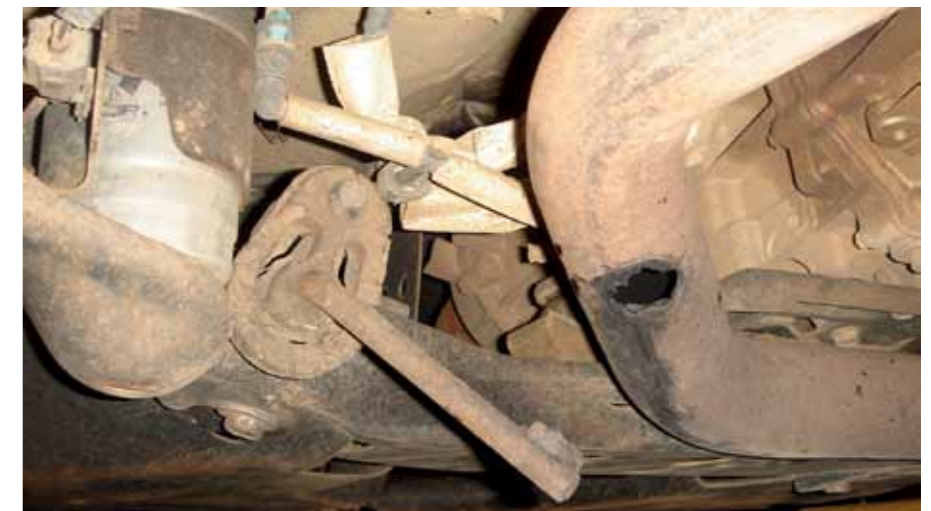
JK CRD

This was odd, the exhaust hanger on the engine pipe of this CRD JK was busted clean off, probably a bad weld. It wasn’t hard to fix with the MIG or hard to find, but why? Who knows.

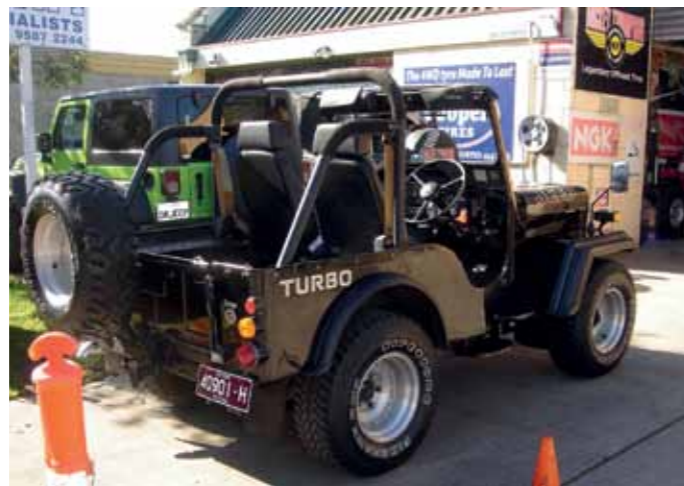
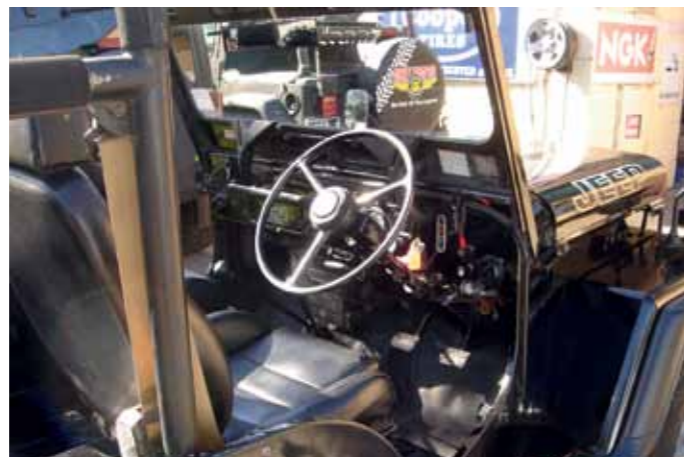
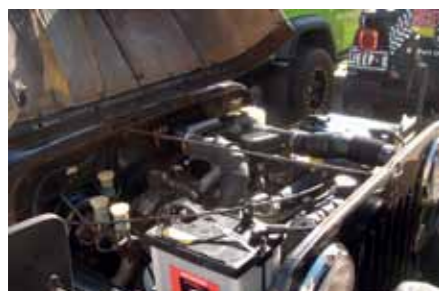
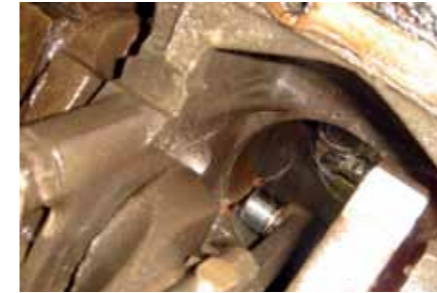
J53

Through the 80's Mitsubishi produced a copy of the CJ3B under license from Jeep. They're a ripper machine, really well made. This one showed up at the shop to say hello recently and I took it for a spin. It has got the same little turbo diesel that the Mitsubishi canter truck had and a full Japanese copy of pretty well every component that the 3B had. It drove extremely well and they are built RHD from Japan. This one was original and on club plates and I must say I was very impressed by it. The body work is original – even the turbo decal!

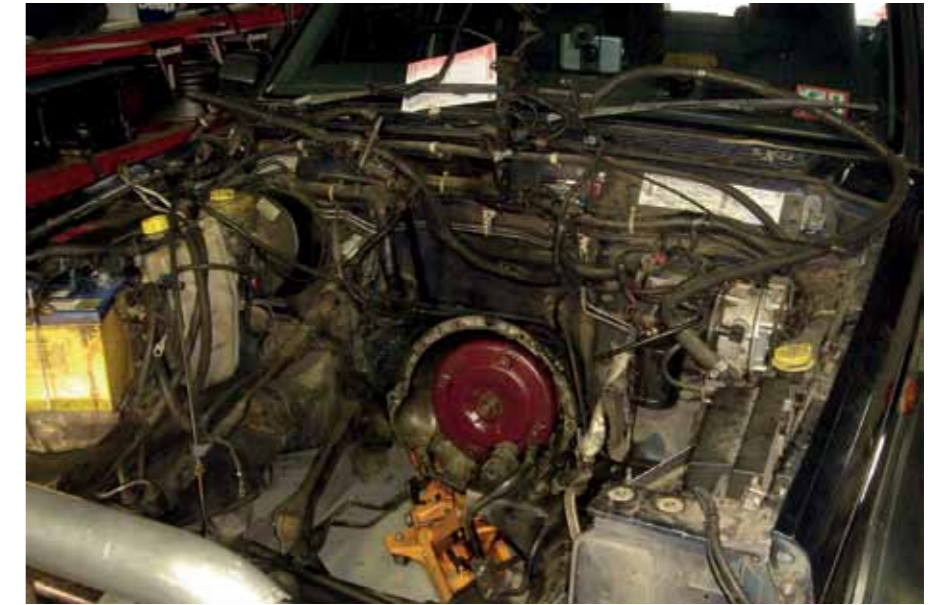
XJ ENGINE SWAP

A gent with a 96 XJ asked us to do a head gasket job on his Jeep and mentioned that there was oil and water mixed showing on the dip stick. I asked how many k's he had on the clock and 350,000 was the reply. Knowing what I do about these 4.0L engines I suggested at this mileage we replace the motor as so many other hidden problems including water jacket cracks and cylinder head cracks can be found. We didn't even bother pulling the head off, instead we extracted the motor as a complete unit.

We removed the sump and after all the shrapnel landed in the drip tray we looked up #6 bore to find the piston gone, but the con rod and gudgeon pin still intact. The XJ was still driving after the piston shattered and the gudgeon had cut a groove in the bore. This is when the coolant flowed into the motor sump and the owner finally thought he better stop as it blew steam up at him. He said it was making a noise too. Really? Anyway it wrote the 350km motor well and truly off.

Hesco 4.0L. It was a coil pack head motor that needed a few mount casting changes that weren't too tricky once both motors were side by side. The distributor drive is the same on all these motors as is the bolt pattern so it was all just a matter of making the accessories all line up properly.

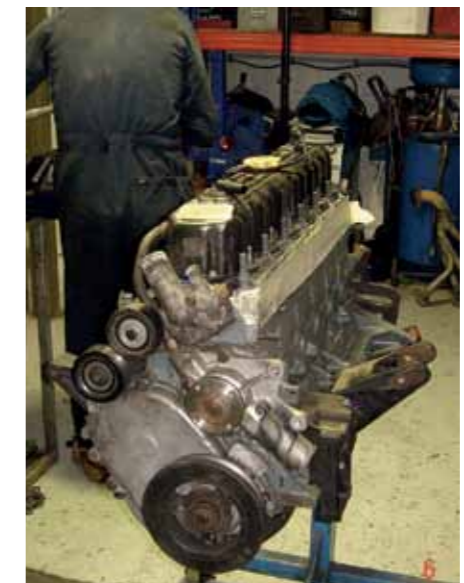
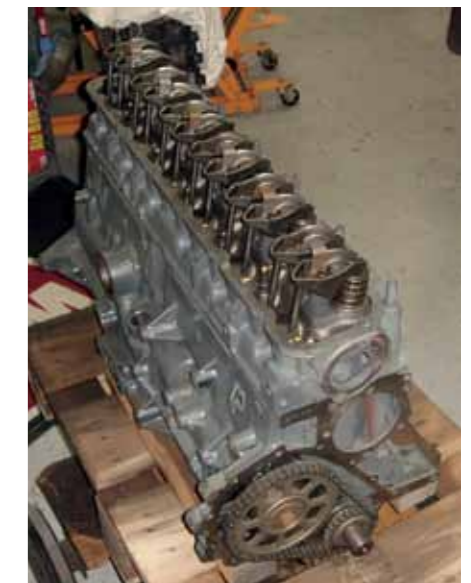
We purchased a fully reconditioned
