can have the grille and radiator removed and the camshaft can be removed from the front of the motor. Second choice is to remove the motor from the Jeep and then remove the camshaft. This CJ7 has a WARN M8274-50 high mount and custom bars meaning extra work to remove the grille. With an easy access engine bay and minimal engine accessories we opted to remove the engine and continue our surgery on the engine stand.

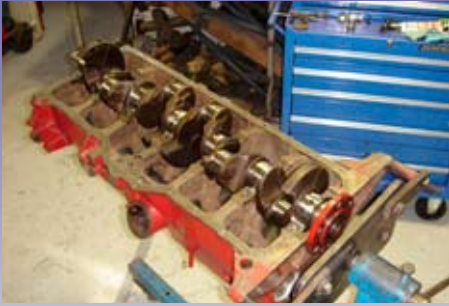
*Motor stripped ready for the crankshaft to be removed*

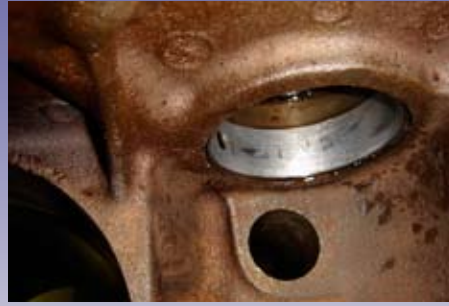
*A badly worn camshaft bearing*

The camshaft was removed to discover a very worn number three exhaust lobe. The sump was now removed to inspect the cam, main and big end bearings. Main and big end bearings looked good but the camshaft bearings were worn and can only be replaced with standard size bearings. That's another job for a specialized engine machine shop. They have the right tools to knock out the old cam bearings, refit and line bore check them. Only problem is they need a bare block so the rest of the motor had to be stripped. This gave us a chance to inspect the rings/pistons and bores by eye, and they were all fine. Ideally when you go this far you would replace the

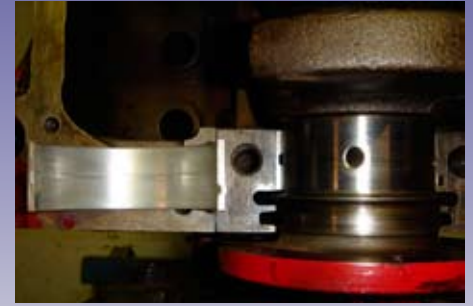
*The rear main bearing cap was good to reuse*

rings and bearings but the cost adds up and after consultation with the owner we were instructed to refit the original rings and bearings.

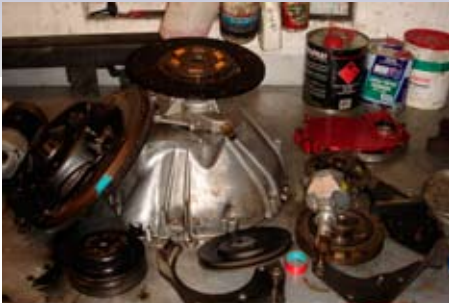
*Bellhousing and other parts cleaned for refitting*

Finally, on with the fly wheel, clutch assembly and on with the bell housing ready to be bolted to the transmission.

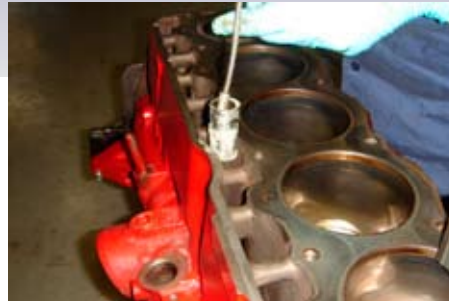
*New lifters being fitted*

With the motor back from the machine shop we were able to reassemble it on the motor stand. First the cam and then the lifters, crankshaft, pistons, then the head and on with the sump using a one piece early 4.0L gasket and the rocker cover, an alloy unit in this case. The 258 Jeep motor had a plastic rocker cover from 1982 to 1985 and they were legendary for warping and leaking. Many after market companies make an alloy replacement cover and this motor fortunately had one.

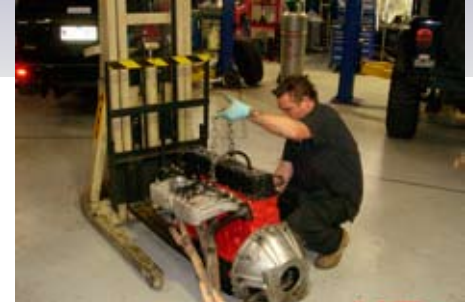
*Manifolds, bellhousing and clutch fitted to motor and Travis prepares the motor to be lifted into the engine bay*

The EFI manifold is customized to fit the older head and fits up nicely with the last of the new gasket kit. The 258 and the 4.0L motor have a lot of similarities, the lifters, sump, timing case, timing set etc are all identical and you can even interchange cranks to stroke a 4.0L with the 258 crank. The bolt pattern is the same too as we proved recently changing

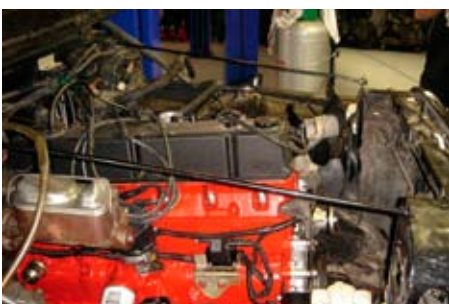
*Motor back in the Jeep*

With the gearbox and transfer case ready we fitted the motor back into the CJ, primed the oil pump by turning the motor over by hand with a fresh 5.7 litres of oil and filter and we'll be running in the cam as soon as it fires. The motor was fired up and run at 1500/2000 rpm for ten minutes or so to run in the cam followed by an oil and filter change as the assembly lube used on the cam and lifters etc will have washed into the engine oil and any metal filings should be caught in the new filter. A test drive of the CJ for any problems and back to the customer who's been with out his baby for three weeks.
