Tony Whitehead (Dr Jeep) diagnoses a problem on a TJ Wrangler

JEEP HOSPITAL

NOISE IN THE FRONT DIFFERENTIAL

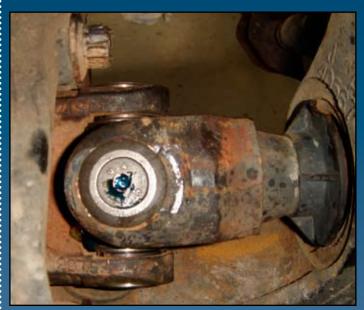
An ungreasable item to keep an eye on in your Jeep is the front axle universal joints. The same joint is used in all the Full Size Cherokees, [10s and]20s running Dana 44 front differentials and in the TJ Wrangler with the Dana 30 front differential. The universal joints are strong enough but have no grease point. When inspecting a front axle universal you need to look for the shades of rust that get spread around the inner steering knuckle. If shades of rust are evident the universal will need removing and with the caps off you will more than likely find considerable rust inside the caps and the needles corroded or worn away. Universals in this condition will fail if not replaced and when it fails it will generally take out one or both axles in the process. Any Jeep being used off road on a regular basis needs constant attention to front axle and drive shaft universals. After a lot of persuasion with our bearing supplier we had them bring in greaseable axle universals that have the grease nipple located in the cap for easy access and when regularly greased will last a lot longer than any stock unit. We fit these to any Jeeps that go off road.

Rust dust evident around the axle universal joint

Greasable universal joint fitted to front axle
